## Specific Site Assessment for Coal Combustion Waste Impoundments at Minnkota Power Cooperative Milton R. Young Station

Center, North Dakota

June 2011  
Project 092884

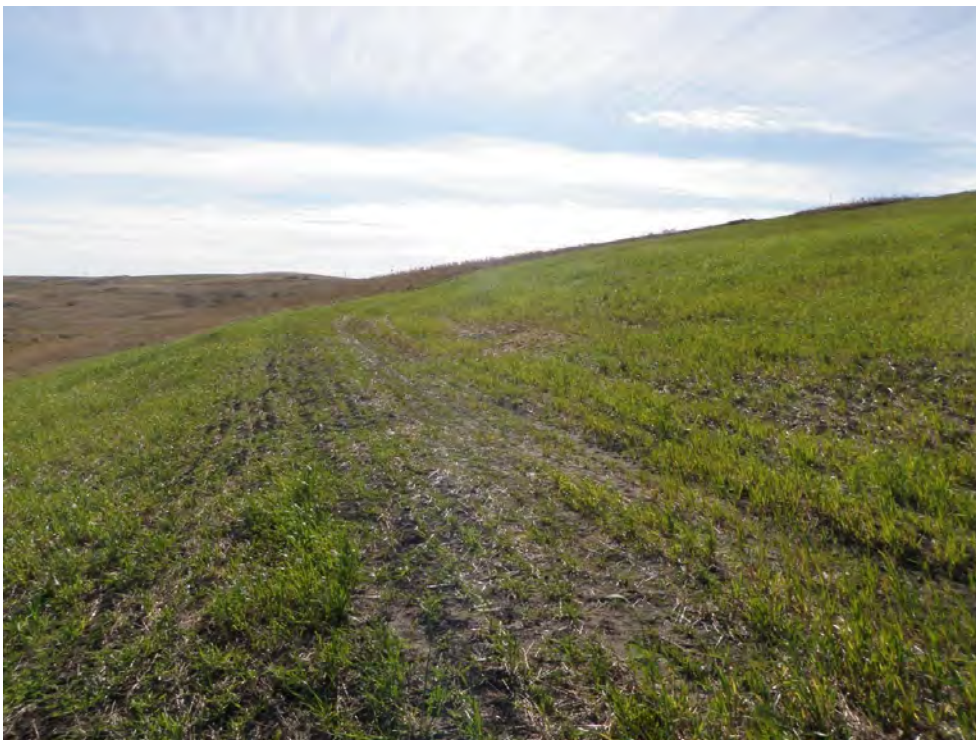
**Photo 32: Cell 2 – East dike downstream slope, looking south.**
